FILE REPORT NO. 02-05

**Evaluation of Potential for Sedimentation
on Natural Oyster Bar 8-11
from Dike Construction at the
Poplar Island Environmental Restoration Project**

by
**Jeffrey Halka
and
Richard Ortt, Jr.**

Prepared for:
Maryland Environmental Service
MPA Contract No: 596924
Pin No. 600105-S

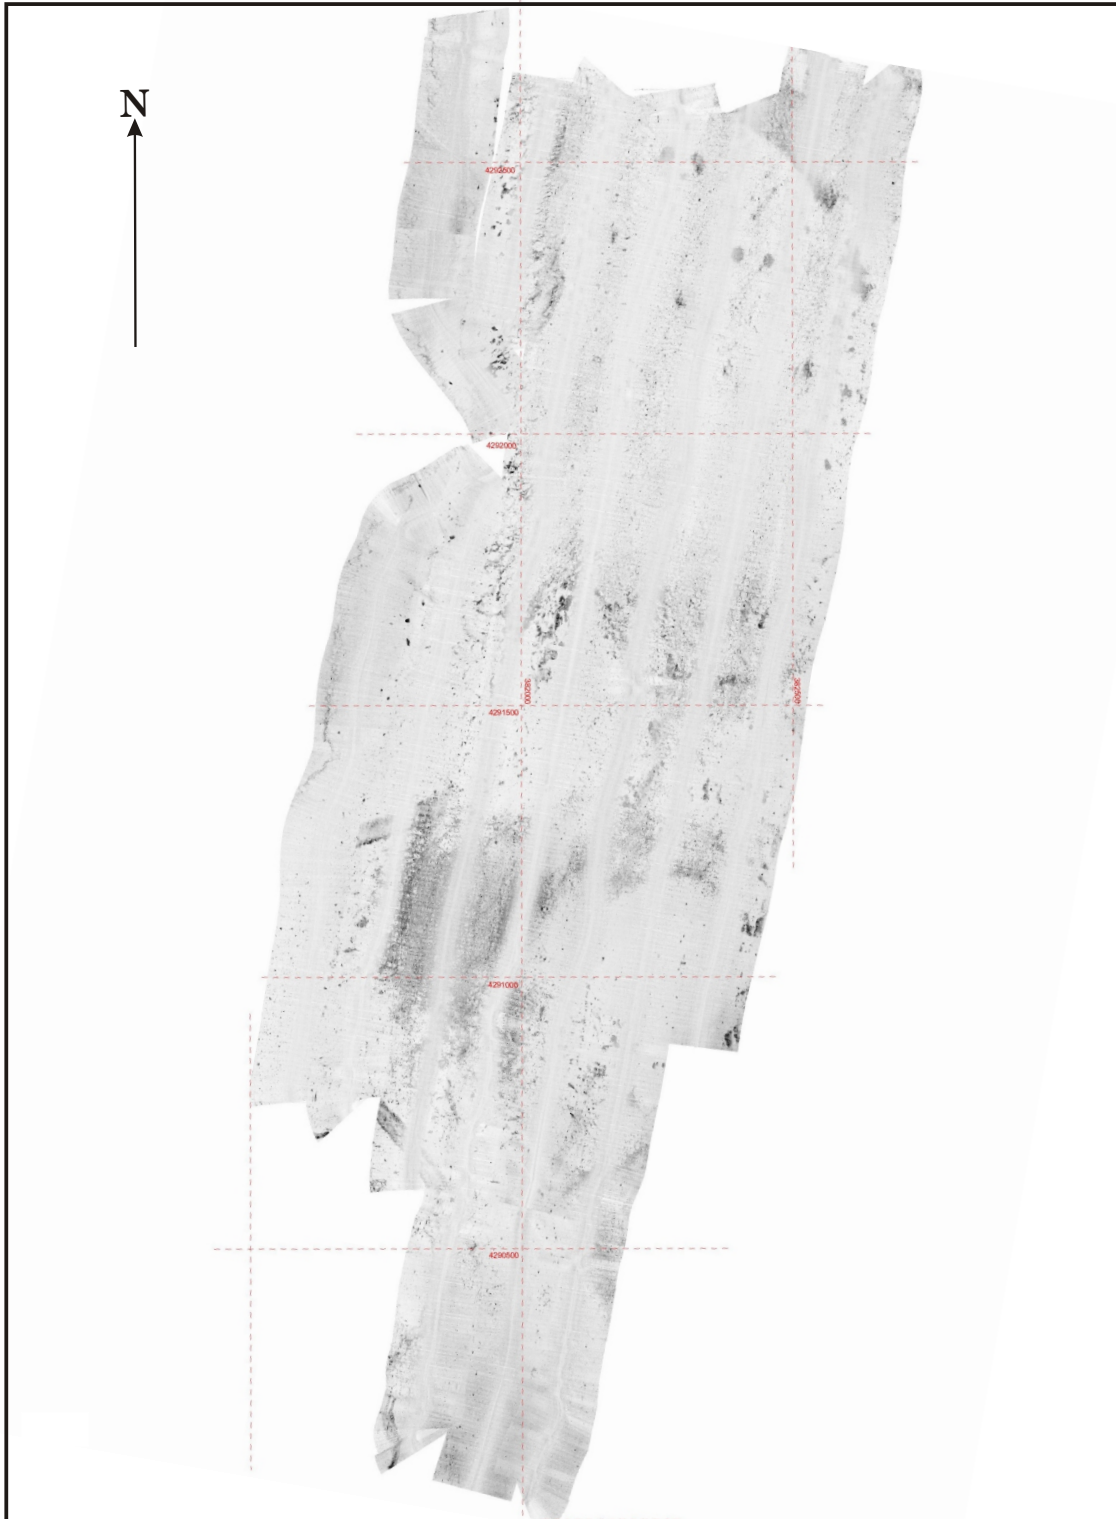
The sand bottom in the area reflects much of the acoustic energy generated by the side-scan sonar equipment. If the bottom is smooth and flat, or facing away from the side-scan unit, the record will appear lighter because much of the incident energy is reflected off the firm surface and away from the equipment sensors, much like light off a mirror. Much of the entire surveyed bottom area of NOB 8-11, consisted of a predominantly sandy bottom that reflected much of the incident energy. This resulted in the nearly featureless image shown in Figure 2. Much of the bottom area is generally featureless, indicating that it was smooth and flat on this survey date. To the southeast of the pound net a relatively large area was hydraulically dredged for clams prior to the survey date. The scars caused by the dredging operation appear as a moderately darker section just below the center of the image, due to the reflectance of more acoustic energy from the irregular and rough bottom. Isolated patches and spots of elevated acoustic reflectance are present to the northeast of the hydraulically dredged area. Some of these darker areas are isolated patches of harder pre-Holocene sediment with only a thin sand covering, similar to those identified to the west of the PIERP (Halka and Ortt, 2000). Some are probably small isolated patches of oyster shells. The southernmost portion of Figure 2, located east of Coaches Island, and closest to the future dike construction area, has an overall smooth and flat character with no evidence of either hydraulic clam dredging, oyster dredging, or oyster shell.

Figure 2: Pre-construction side-scan sonar mosaic collected within the area shown on Figure 1. Note the relatively reflection free nature of the smooth and flat sandy bottom in the area surveyed. See text for explanation of image quality. Survey conducted August 15, 2000.

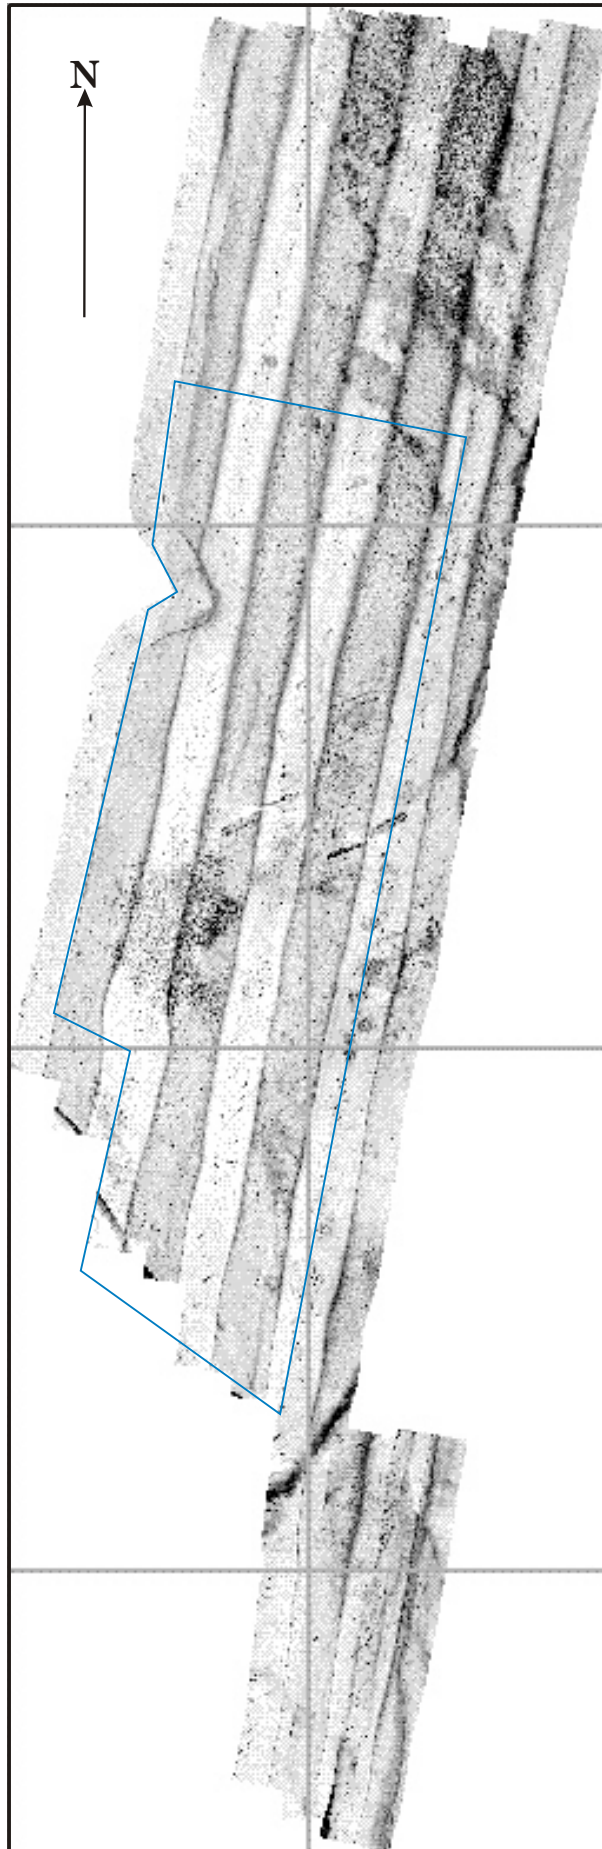
survey (Figure 3). Most of the area remained predominantly smooth and flat, particularly in the vicinity of Coaches Island. The hydraulic clam dredging scars were still present in the same area as on the pre-construction survey, indicating that these scars can persist for a substantial length of time even in an area of relatively large fetch and tidal currents. A close up of the dredge area is shown in Figure 4, where the individual scars on the bottom can be clearly identified.

A comparison of the pre- and post-construction side-scan sonar records in the vicinity of the dike construction area provided no indication that additional sediment moved into the boundary of NOB 8-11 as a result of construction activities. Proximal to the dike the bottom appeared to be largely smooth and flat sands both prior to and following construction. The hydraulic dredge scars that were identified on the pre-construction survey were still present following construction indicating that no sandy sediments moved into this vicinity and covered the scars. There was no evidence that dike construction activities had produced any movement of sand into the boundaries of NOB 8-11.

Figure 3: Post-construction side-scan sonar mosaic collected within the area shown on Figure 1. The pre-construction survey area shown on Figure 2 is outlined in blue for reference. See text for details. Survey conducted August 8, 2001.

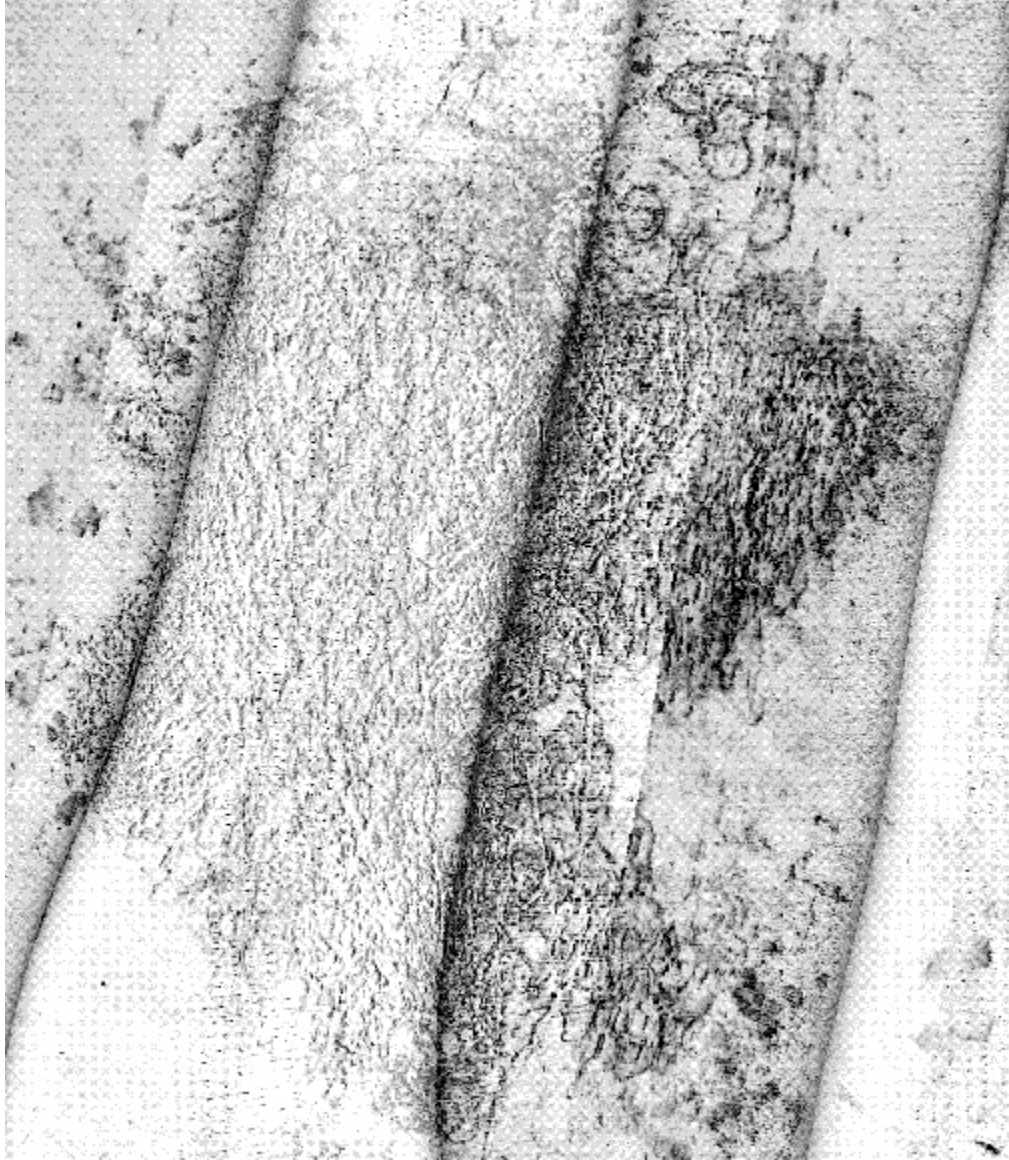
Figure 4: Side-scan sonar image of sandy bottom Northeast of Coaches Island showing evidence of hydraulic clam dredging scars. Location of this figure is indicated on Figure 1.

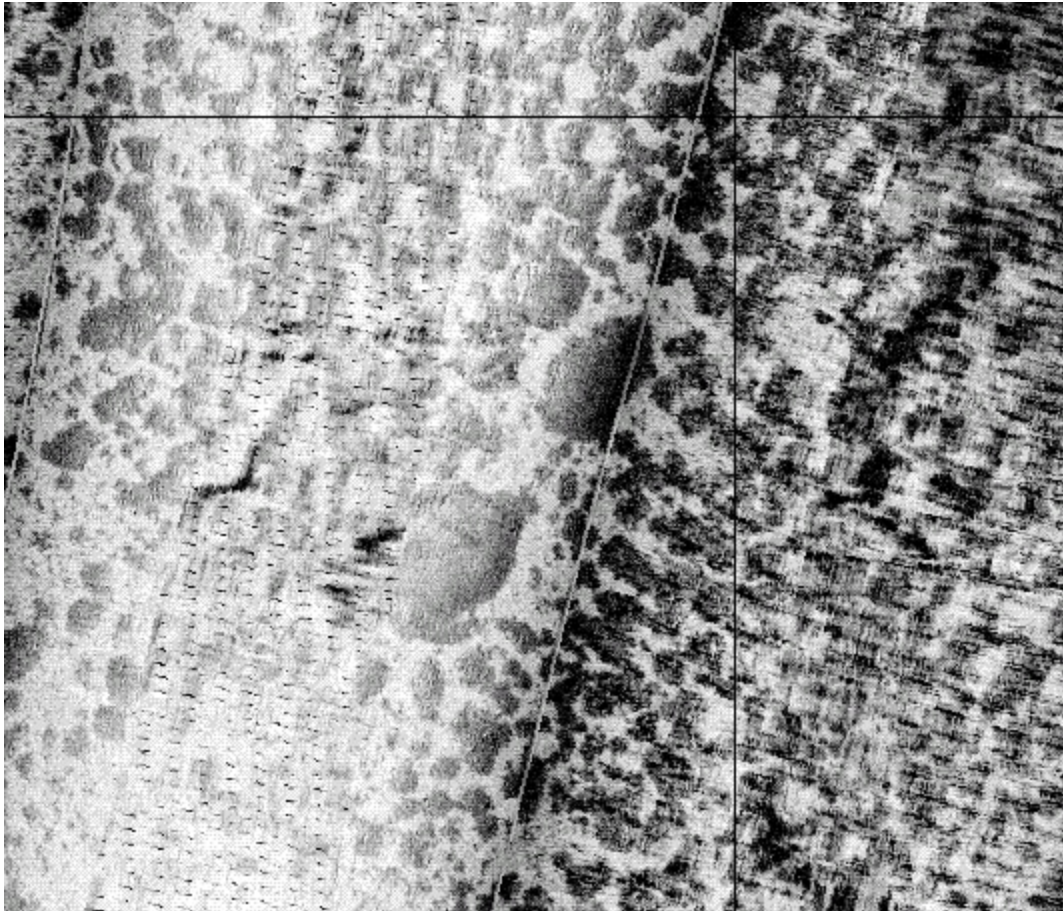
The area surveyed following completion of dike construction extended beyond the limits of pre-construction surveyed area. Coverage extended to the south to determine if the bottom characteristics in that area differed from the smooth sandy nature identified on the initial survey. Coverage extended to the north mainly to improve coverage within NOB 8-11, even though there was little chance that there would have been impacts detected at this distance from the construction activities. At the northern end of the surveyed area, large patches of bottom with different reflection characteristics were present (Figure 5). These were interpreted to represent numerous clusters of oyster shells on the bottom and were similar to bottom reflections observed on NOB 8-10 that were identified as oyster shells by diving (Halka and Ortt, 2002).

Figure 5 Side-scan sonar image of oyster shell clusters in the northern portion of the post-construction surveyed area. Location identified on Figure 1.
